Characterisation of Damage Layers in JET Langmuir Probes

- An NNUF Funded Experiment

By Rob Kerr

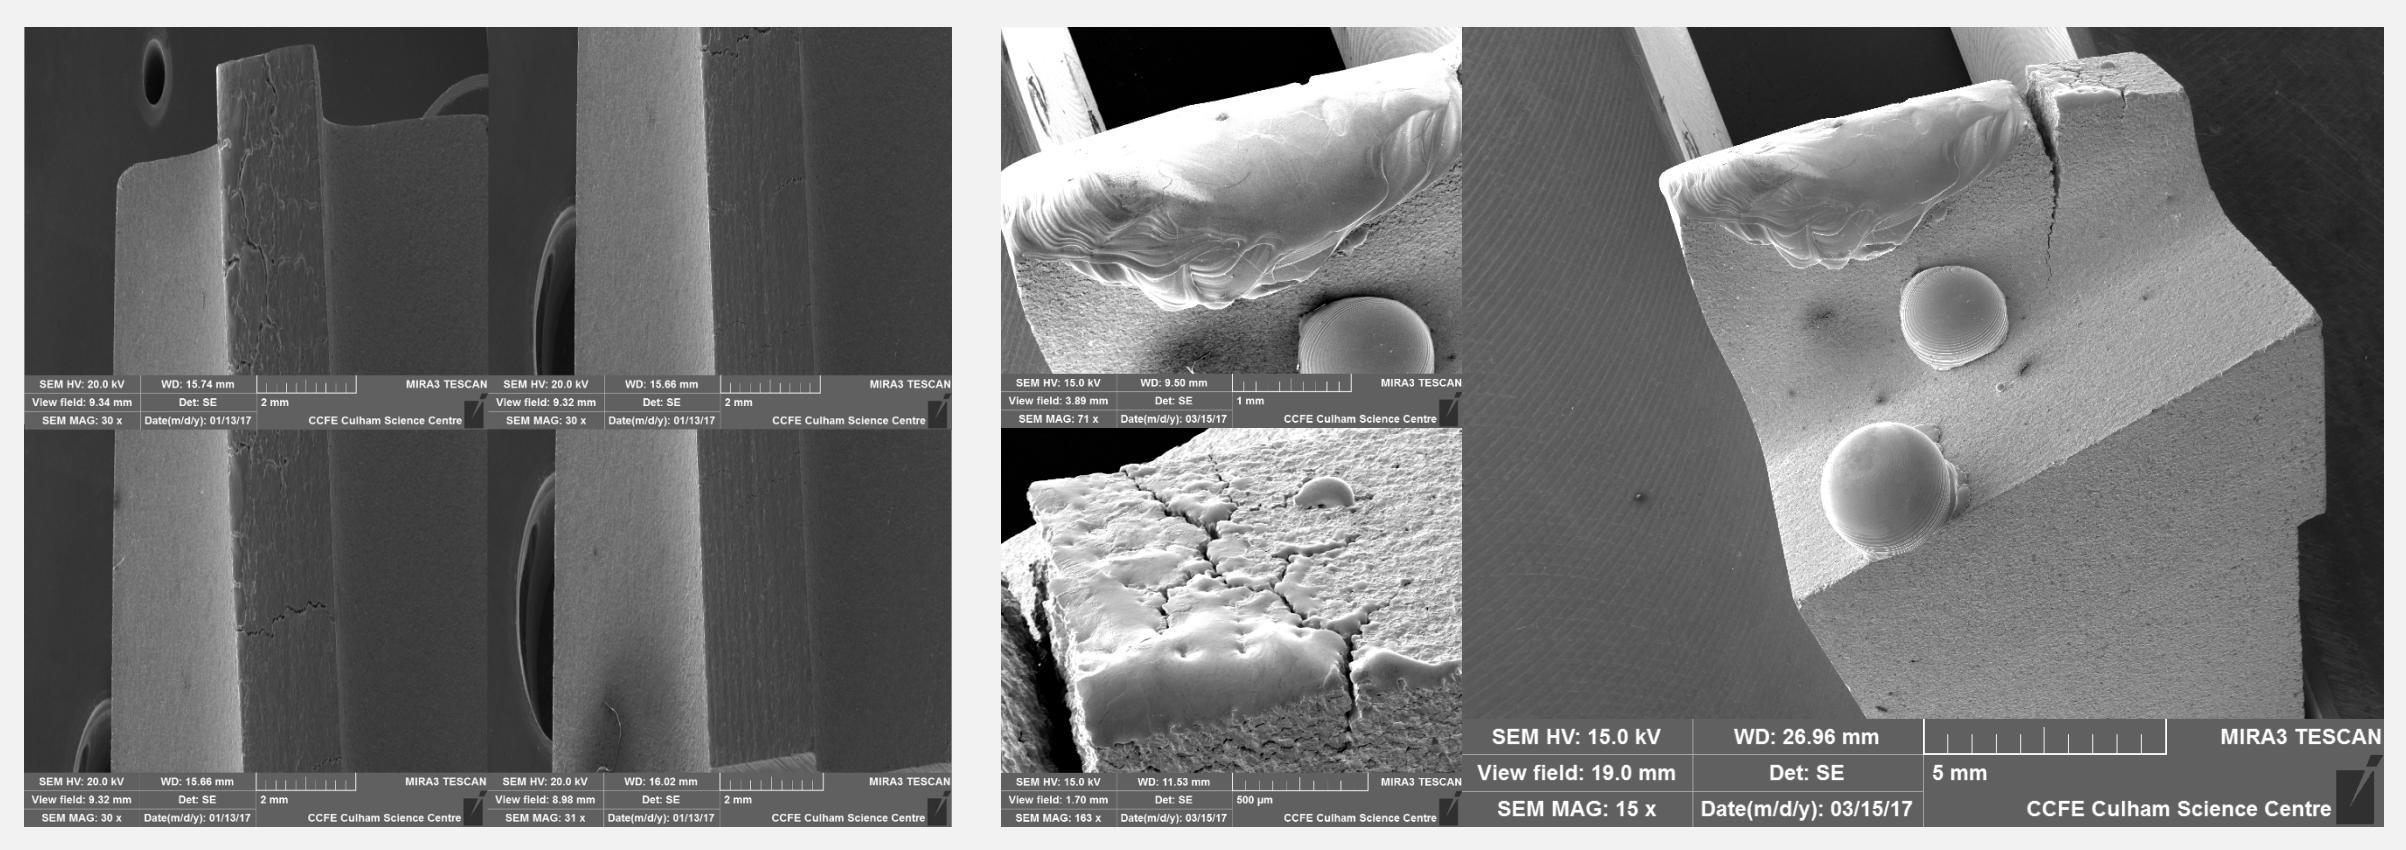
- Sample 1 was positioned near tile 3 and many large cracks had formed across the exposed surface and into the bulk
- Sample 2, placed near tile 6, showed clear signs of melt damage, suggesting exposure to higher heat loads

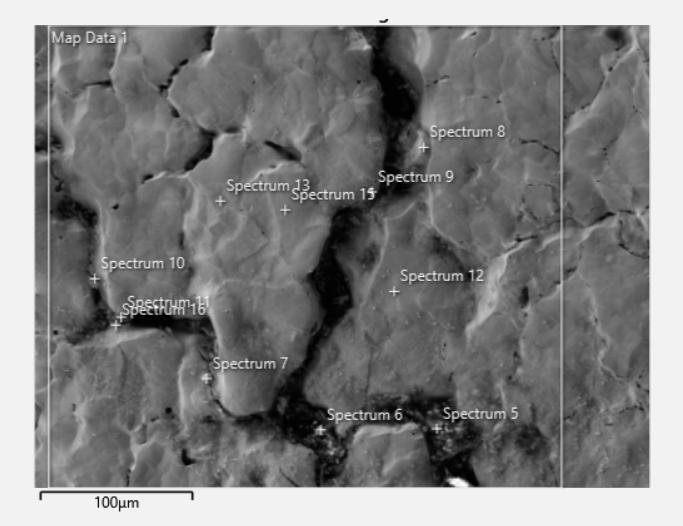
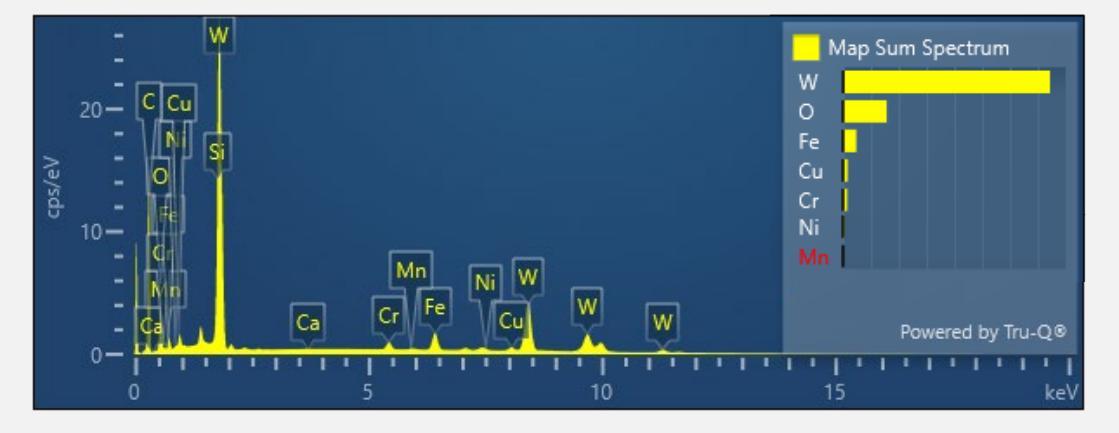
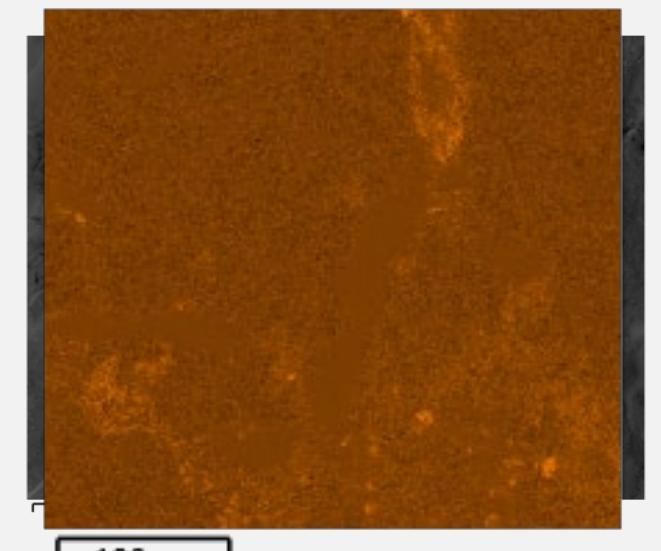
Exposed Surface EDX – Sample 1

- EDX points to the deposition of Fe, Cr & Ni on both samples and Cu in sample 1
- Grain size had increased from 33 μm in the as received to 40 μm at the surface in sample 1
- Sample 2 was completely recrystallized to a grain size of $517 \ \mu m$
- Indentation suggests larger grains are the reason for the reduction in hardness
