UK Nuclear Academics Meeting

Collaboration with Japan

12th September 2019

Decommissioning status – Fukushima Daiichi

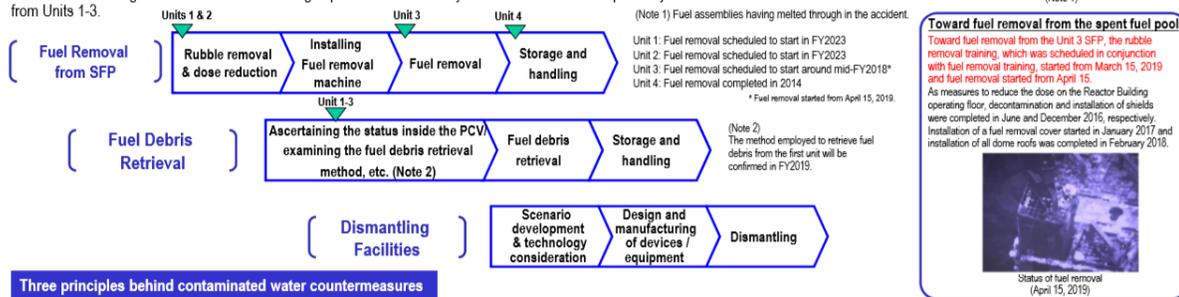
Main decommissioning work and steps

Fuel removal from the Unit 4 SFP was completed on December 22, 2014 and removal from the Unit 3 SFP has been underway since April 15, 2019. Dust density in the surrounding environment is being monitored and work is being implemented with safety first. Work continues sequentially toward the start of fuel removal from Units 1 and 2 and debris retrieval from Units 1-3.

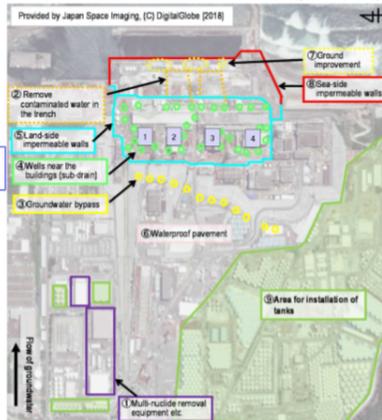
1 Remove contamination sources

- 1 Purification by using Multi-nuclide removal equipment, etc.
 - 2 Remove contaminated water from the trench (Note 3)
- (Note 3) Underground tunnel containing pipes.

2 Redirect groundwater from contamination sources

- 3 Pump up groundwater by bypass
- 4 Pump up groundwater near buildings
- 5 Land-side impermeable walls (Frozen-soil walls)
- 6 Waterproof pavement

3 Prevent leakage of contaminated water

- 7 Enhance soil by adding sodium silicate
- 8 Sea-side impermeable walls
- 9 Increase the number of (welded-joint) tanks
